Opera Assessment Report Revision 2

Independent Assessment of Eskom's Operational Situation

August 2023

Client:	National Treasury of South Africa	
Project No:	NT015/2022	
Report Title:	Opera Assessment Report – Revision 1	
Report No:	2 NT_Eskom	
Main Authors:	Bartosz Zajda (Dornier) Manswet Banka (Dornier) Klaus Bransch (Dornier) Vladan Dokic (Dornier) Pieter Janse van Rensburg (Dornier) Dr. Thomas von Schieszl (Dornier) Jörg-Schulte Trux (KWS) Ralf Wiescher (KWS) Rainer Zobel (KWS) Axel Meschbiz (RWE) Petros Terzis (RWE)	Volkmar Bobon (STEAG) Dietmar Breuer (STEAG) Dr. Ruth Egyptien (STEAG) Werner Renk (STEAG) Sener Günes (vgbe) Bernhard Michels (vgbe) Dr. Mark Newby (vgbe) Dr. Claudia Stockheim (vgbe) Dr. Oliver Then (vgbe) Dr. Christian Ullrich (vgbe) Dr. Claudia Weise (vgbe)
Date of Issue:	August 2023

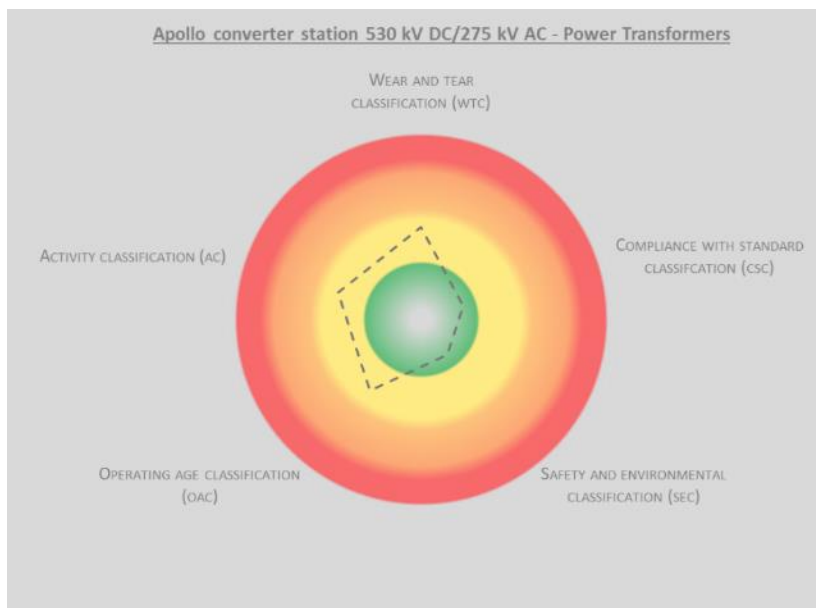
Figure 9-42: Evaluation graphic transformers Apollo Converter Station 530 kV DC/275 kV AC

The majority of the transformers are in good overall condition. The maintenance condition is very good. The 4 transformers with very poor oil analysis values are to be monitored (see Figure 9-42).

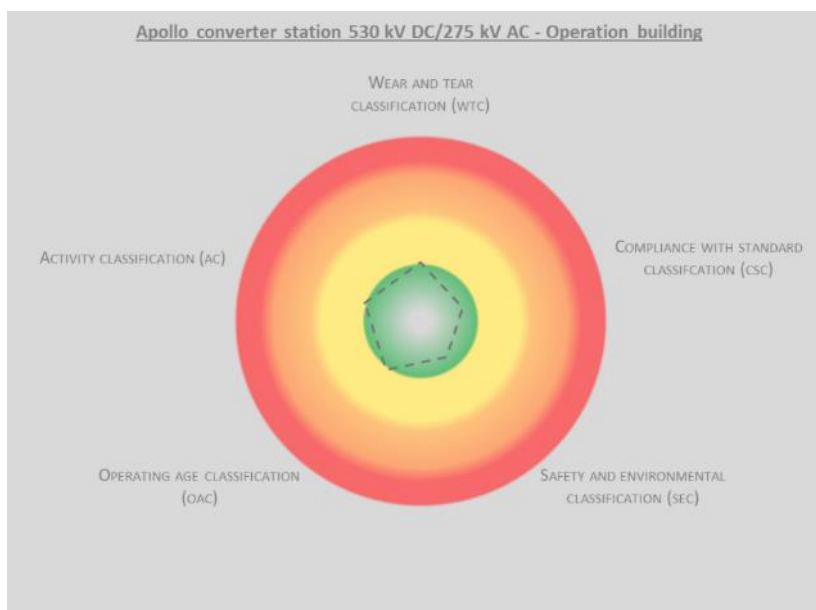
Figure 9-43: Evaluation graphic Operation Building Apollo Converter Station 530 kV DC/275 kV AC

Activity class of the operation building classification 1,36 – Slight wear due to age, condition without findings, no measures necessary.

Despite its many years of use, the operation building is in excellent condition. Cleanliness and maintenance condition are excellent (see Figure 9-43).

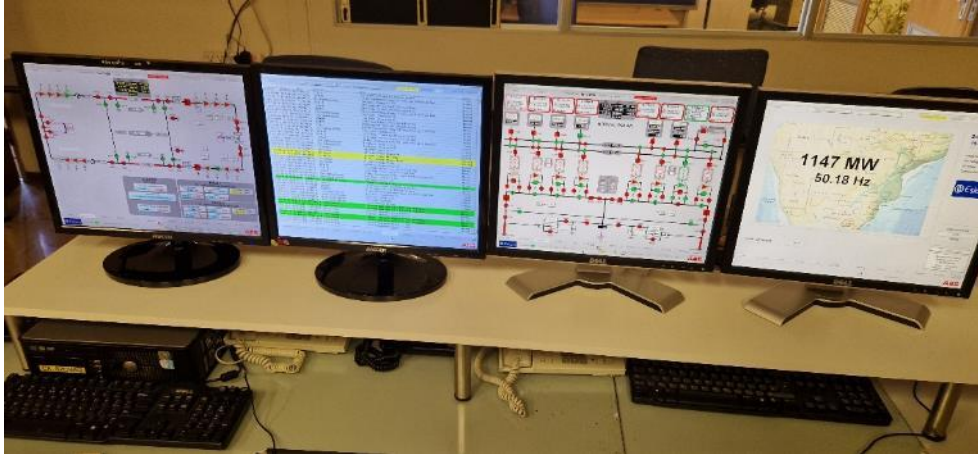
Figure 9-44: Control desk Apollo Converter Station 530 kV DC/275 kV AC

Activity class of Secondary Technology classification 1,5 – The equipment and software used to control and monitor the converter bank are outdated but fulfil all functions. Most of the protection technology has been modernised, no measures necessary (see Figure 9-44).

- SCADA outdated equipment and software AC classification 2 – modernization recommended, no immediate measures required.

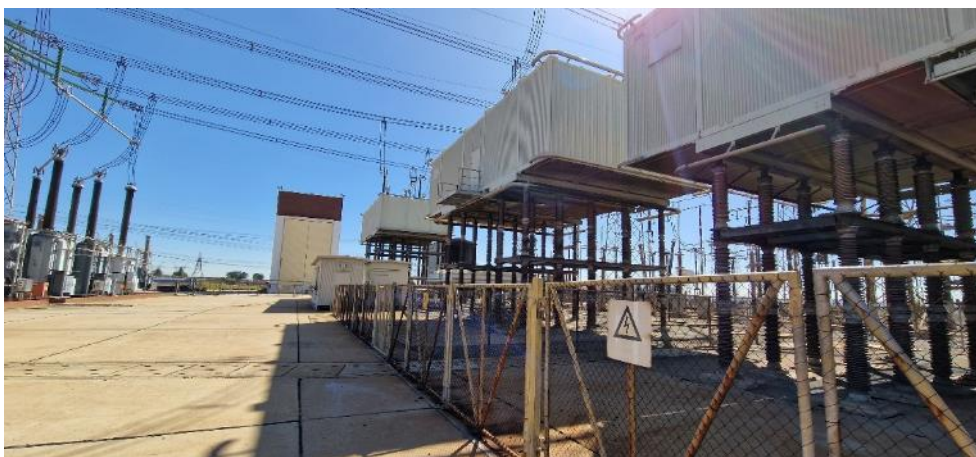
Figure 9-48: Street and fences Apollo Converter Station 530 kV DC/275 kV AC

Activity class of streets, footpaths and fences classification 1,67 – small wear and tear, no measures required (see Figure 9-48).

- General condition AC classification 2 – small wear and tear, no measures required.
- Fences and security AC classification 2 – small wear and tear, no measures required.
- Dimensioning AC classification 1 – small wear and tear, no measures required.

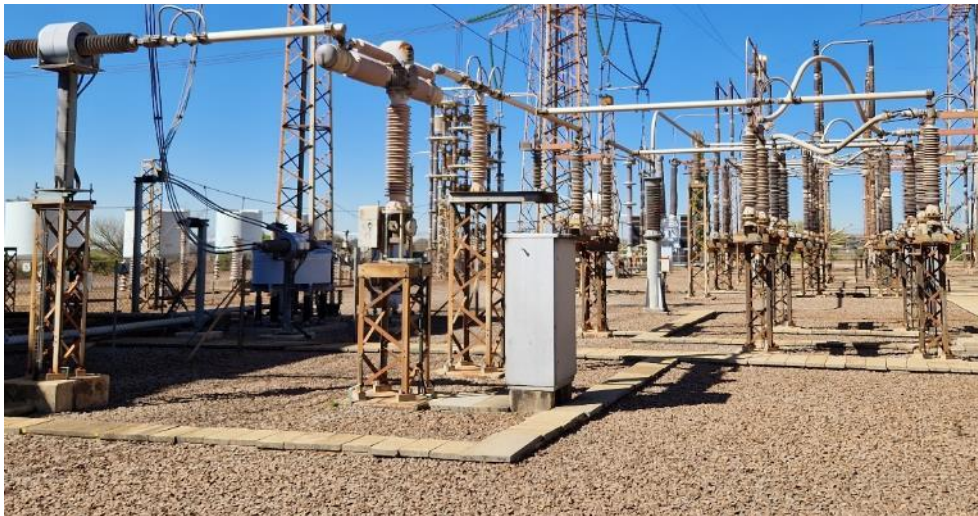
Figure 9-50: Cable ducts Apollo Converter Station 530 kV DC/275 kV AC

Activity class of cable ducts classification 2 – Age-related wear and tear, but in a very good state of maintenance (see Figure 9-50).

- Ducts AC classification 2 – Age-related wear and tear, no measures required.
- Covers AC classification 2 – Age-related wear and tear, no measures required.
- General condition, weathering AC classification 2 – Age-related wear and tear, no measures required.

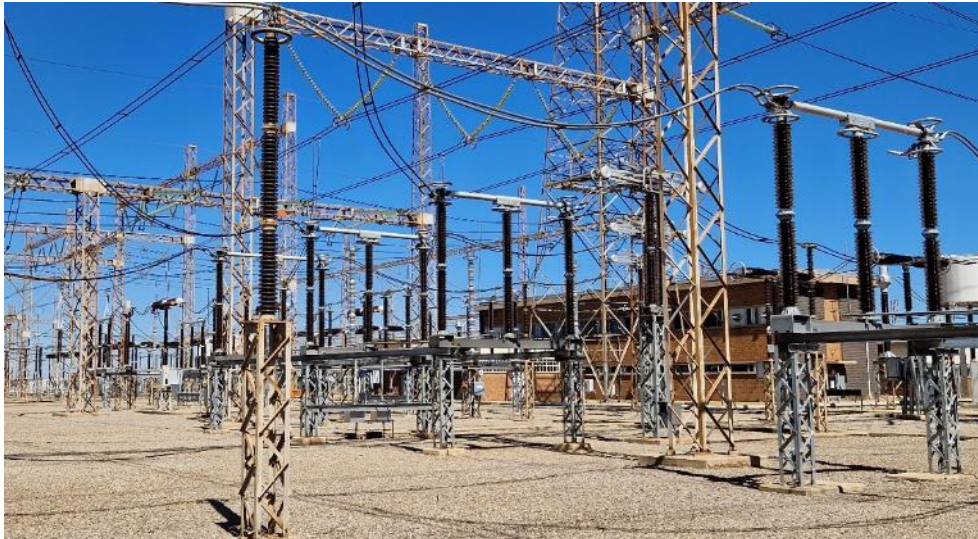
Figure 9-55: Modernized 400 kV switchgear substation Apollo 400/275 kV

Activity class of switchgears classification 1,5 – The main devices (circuit breakers, instrument transformers, disconnectors) were renewed during the modernisation in 2013, with a few exceptions in the 275 kV switchgear. Age-related wear and tear, no measures required (see Figure 9-55)

- New 6 SF₆-circuit-breakers AC classification 400 kV 1, 275 kV 2 – few low oil circuit breakers in 275 kV still in operation, replacement recommended in medium term.

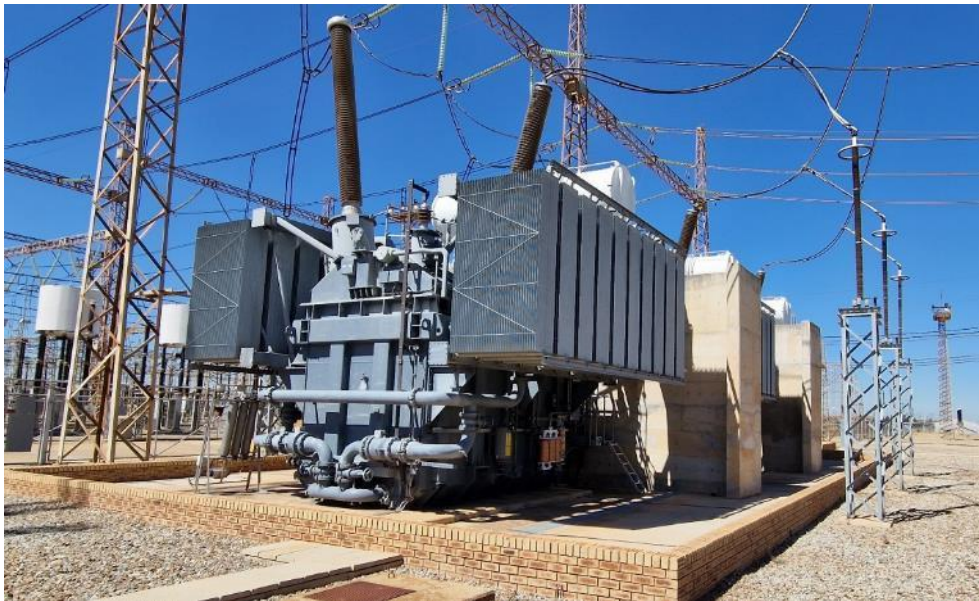
Figure 9-57 Power Transformer pole substation Apollo 400/275 kV

Activity class of Power Transformers (in operation since TRFR 1 2017, TRFR 2 2015, TRFR 3 1989) classification 1,11 – The two newer transformer banks have a classification A very good of the last gas to oil analysis test values except for pole 1 of transformer 1. This has only a classification C fair test value, as does transformer 3, which has been in operation for over 30 years. No immediate action is required, but the gas in oil analysis test values should be monitored for deterioration (see Figure 9-57).

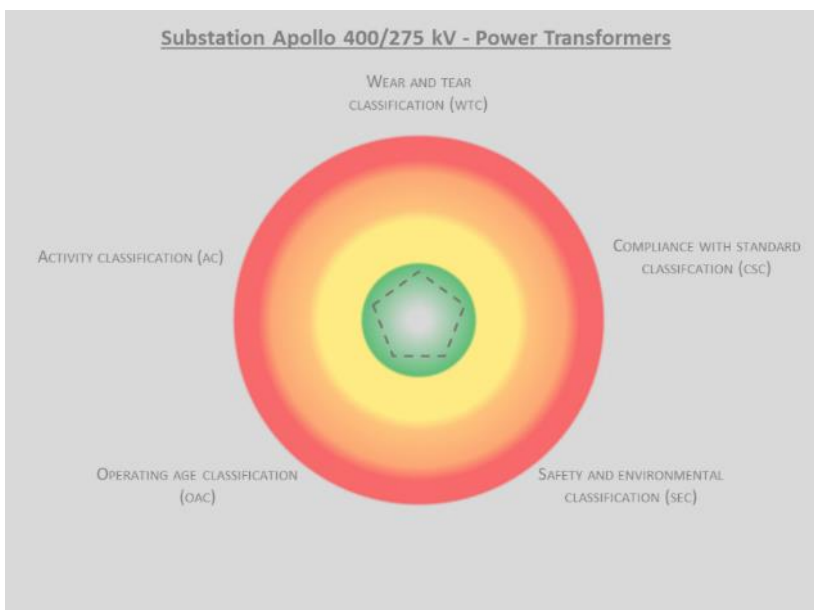
Figure 9-58: Evaluation graphic Power Transformer substation Apollo 400/275 kV

The two new power transformers 1 and 2 are in good condition. The older power transformer 3 has age-related wear and tear but no immediate measures are required. The gas in oil analysis test values of the transformers with last test classification C should be monitored for deterioration. Cleanliness and maintenance condition are excellent (see Figure 9-58).

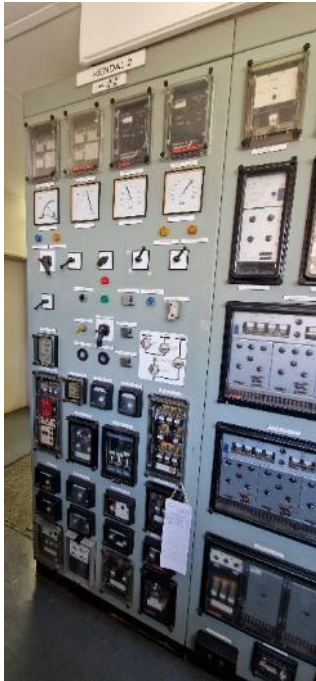
Figure 9-61: Outdated secondary technology substation Apollo 400/275 kV

Activity class of Secondary Technology classification 1,5 – Most of the SCADA components were renewed. The protection technology has been partially modernised but a high percentage are still electromechanical technology, nevertheless no immediate measures are necessary (see Figure 9-61).

- SCADA connection is available AC classification 1 – modernization activities implemented, no immediate measures required.
- Protection relays are modernized only partly AC classification 2 – further modernization activities recommended at least in medium time, no immediate measures are necessary.

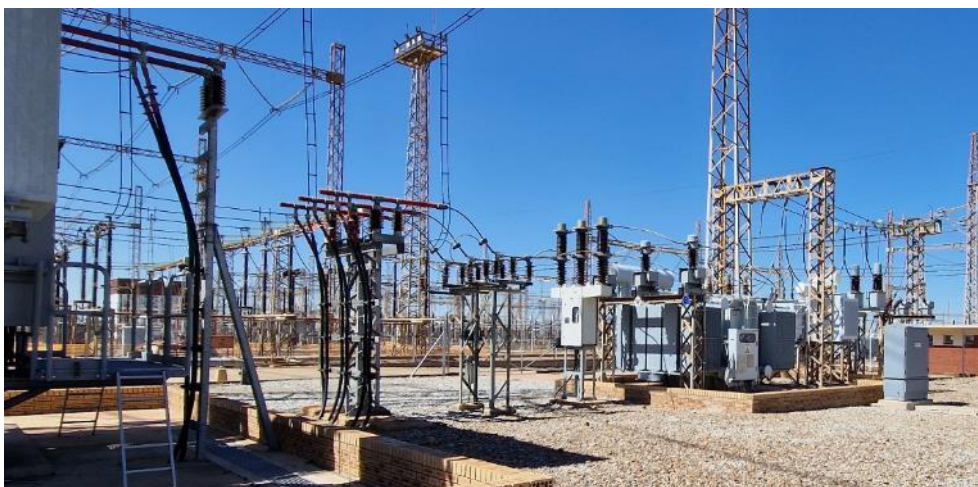
Figure 9-63: Part of auxiliary system substation Apollo 400/275 kV

Activity class of AC/DC systems classification 1,33 – Age-related wear and tear, no measures required, auxiliary transformers were replaced in 2016, 2021 and 2022 (see Figure 9-63).

- AC system including auxiliary transformers and AC-distribution AC classification 1 – condition without findings.
- DC-distribution AC classification 2 – Age-related wear and tear, no measures required.
- AC/DC converters AC classification 1 – Age-related wear and tear, no measures required.

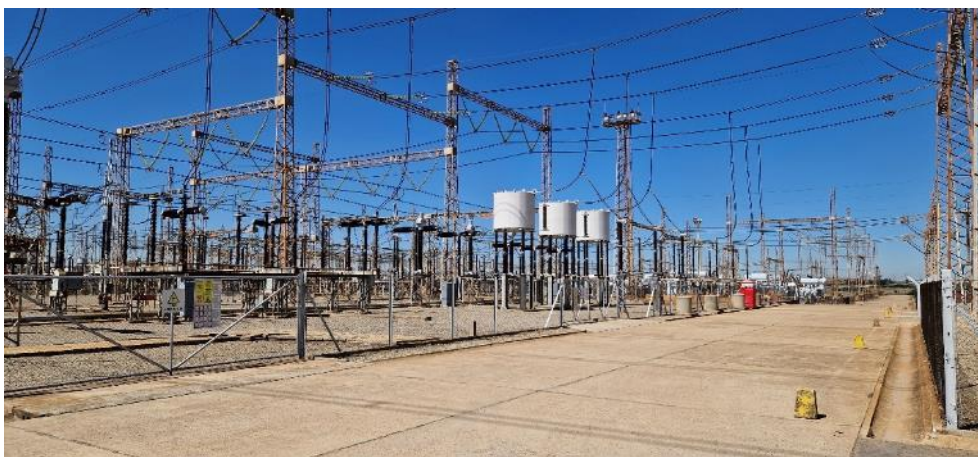
Figure 9-67: Street and fences substation Apollo 400/275 kV

Activity class of streets, footpaths and fences classification 1 – small wear and tear, no measures required (see Figure 9-67).

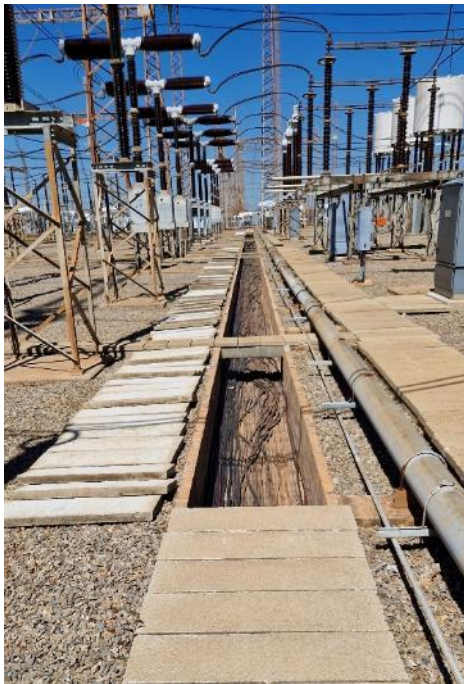
Figure 9-69: Cable duct substation Apollo 400/275 kV

Activity class of cable ducts classification 2 – Age-related wear and tear, but in a very good state of maintenance (see Figure 9-69).

- Ducts AC classification 2 – Age-related wear and tear, no measures required.
- Covers AC classification 2 – Age-related wear and tear, no measures required.
- General condition, weathering AC classification 2 – Age-related wear and tear, no measures required.

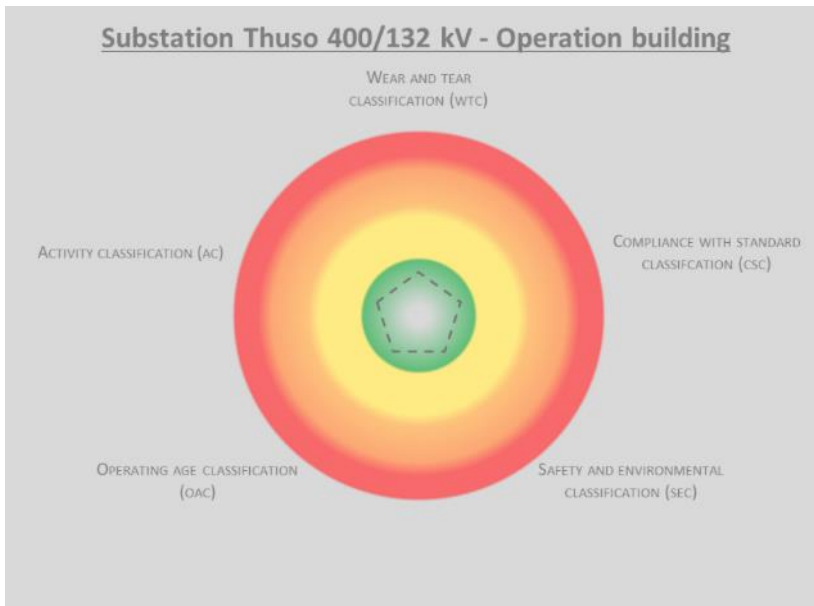
Figure 9-79: Evaluation graphic of Operation Building of substation Thuso

The operation building corresponds to the condition that it was commissioned less than ten years ago. Cleanliness and maintenance condition are excellent (see Figure 9-79).

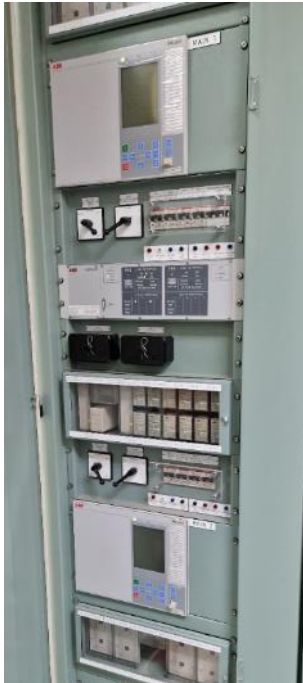
Figure 9-80 Example of a protection cabinet in substation Thuso

Activity class of Secondary Technology classification 1 – condition without findings, no measures necessary (see Figure 9-80)

- SCADA according to the current state of the art AC classification 1 – condition without findings.
- Protection relays are all digital, according to the current state of technology AC classification 1 – condition without findings.
- Control room and equipment AC classification 1 – condition without findings.

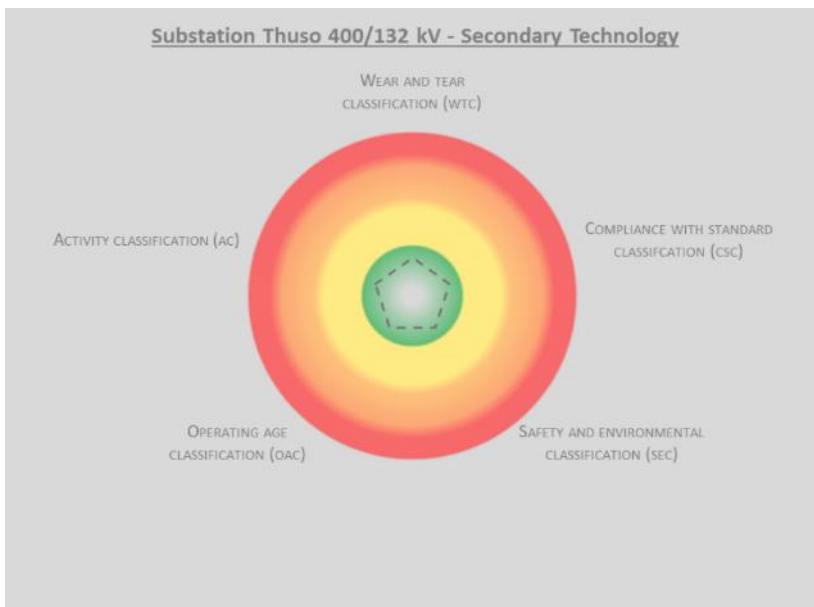
Figure 9-81: Evaluation graphic of Secondary Technology in substation Thuso

The secondary technology corresponds to the condition that it was commissioned less than ten years ago, and is according to the current state of technology. Cleanliness and maintenance condition are excellent (see Figure 9-81).

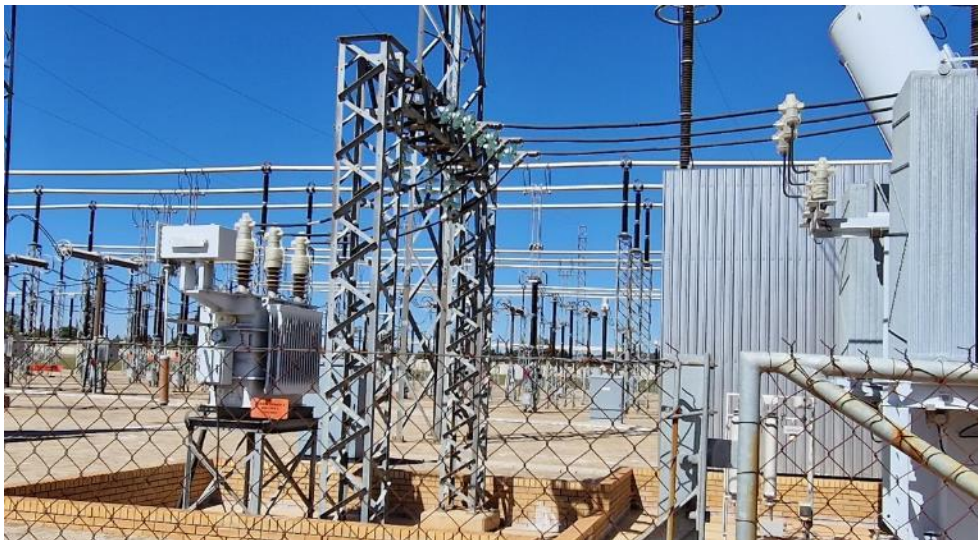
Figure 9-82: Auxiliary transformer as example of one component of the AC/DC system

Activity class of AC/DC systems classification 1 – condition without findings, no measures necessary (see Figure 9-82).

- AC system including auxiliary transformers and AC-distribution AC classification 1 – condition without findings.
- DC-distribution AC classification 1 – condition without findings.
- AC/DC converters AC classification 1 – condition without findings.

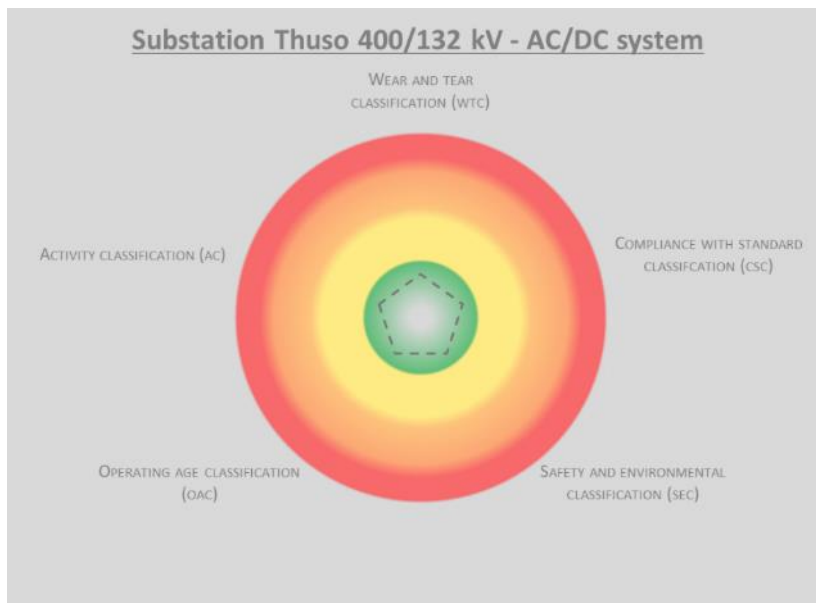
Figure 9-83: Evaluation graphic of AC/DC systems of substation Thuso

The AC/DC systems correspond to the condition that it was commissioned less than ten years ago and is according to the current state of technology. Cleanliness and maintenance condition are excellent (see Figure 9-83).

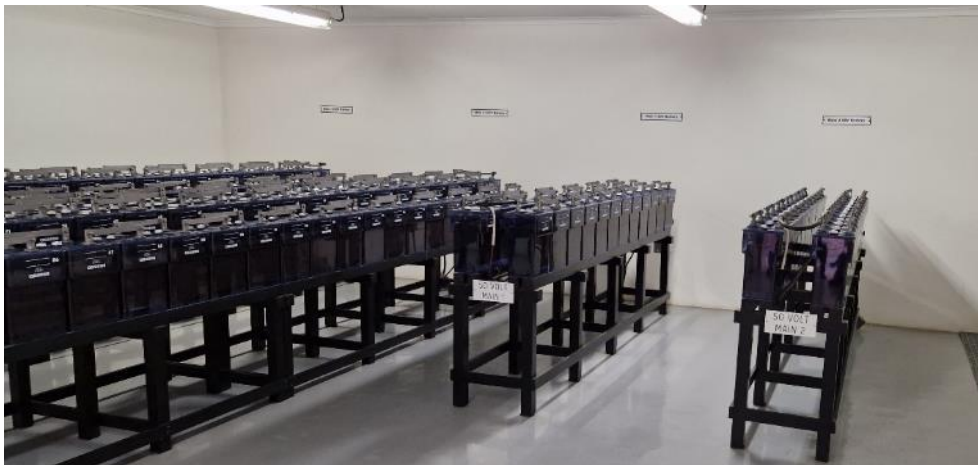
Figure 9-84: Battery room of substation Thuso

Activity class of Battery systems classification 1 – condition without findings, no measures necessary (see Figure 9-84).

- 220 V Batteries AC classification 1 – condition without findings.
- 50 V AC classification 1 – condition without findings.

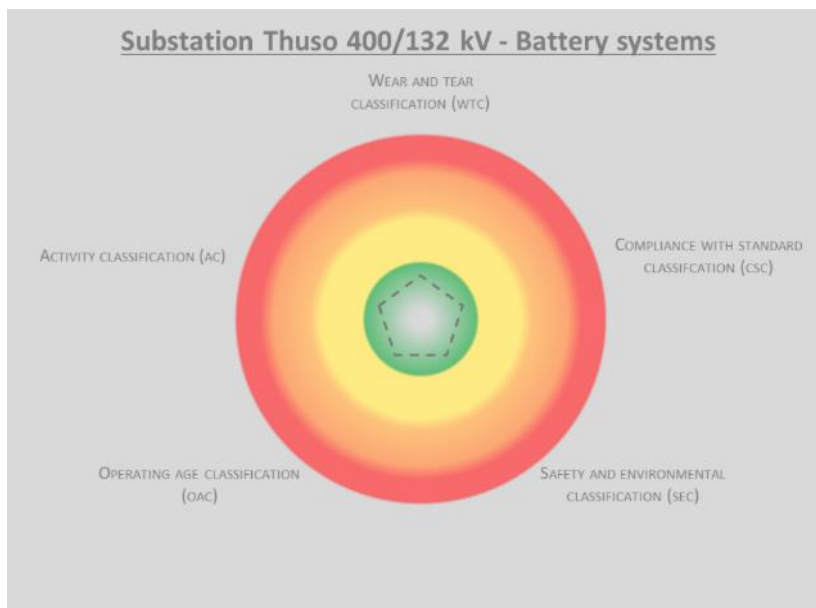
Figure 9-85: Evaluation graphic of Battery systems

The Battery systems correspond to the condition that it was commissioned less than ten years ago and is according to the current state of technology. Cleanliness and maintenance condition are excellent (see Figure 9-85).

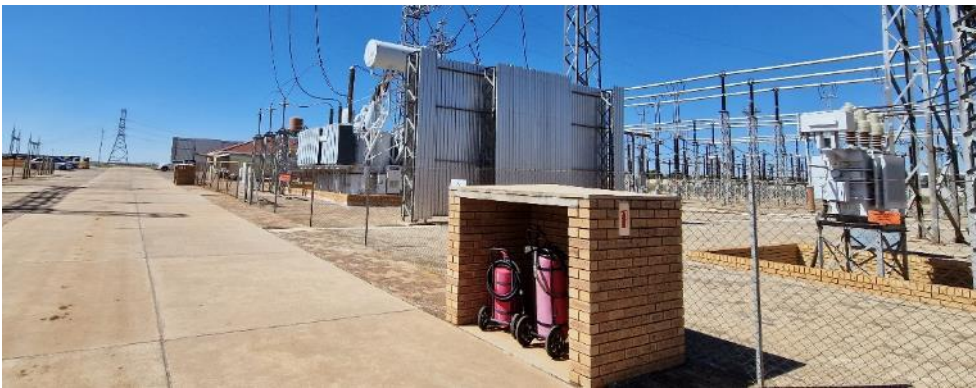
Figure 9-86: Transportation street and fence of substation Thuso

Activity class of streets, footpaths and fences classification 1 – condition without findings, no measures necessary (see Figure 9-86).

- General condition AC classification 1 – condition without findings.
- Fences and security AC classification 1 – condition without findings.
- Dimensioning AC classification 1 – condition without findings.

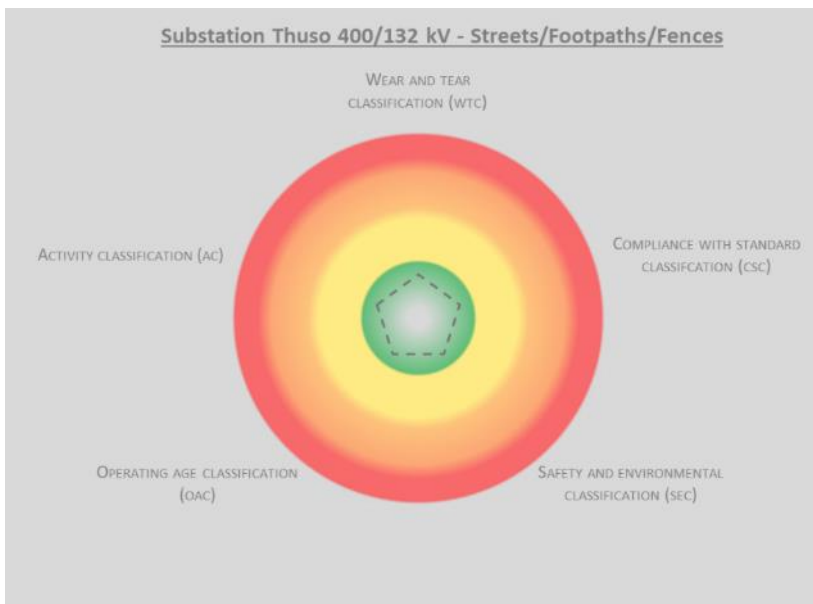
Figure 9-87: Evaluation graphic of streets, footpaths and fences in substation Thuso

The streets, footpaths and fences correspond to the condition that it was commissioned less than ten years ago and is according to the current state of technology. Cleanliness and maintenance condition are excellent (see Figure 9-87).

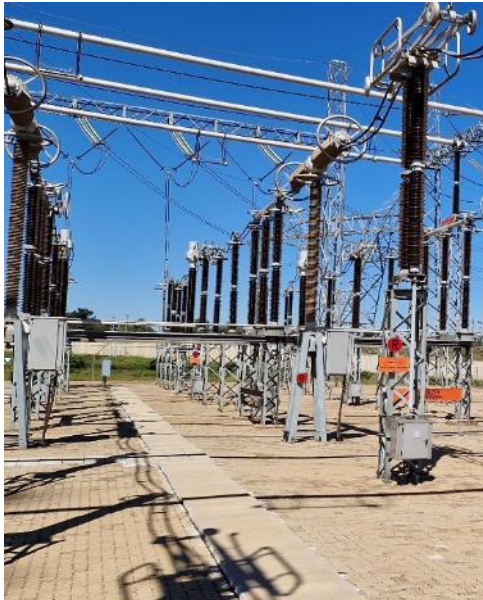
Figure 9-88: Cable duct in substation Thuso

Activity class of cable ducts classification 1 – condition without findings, no measures necessary (see Figure 9-88).

- Ducts AC classification 1 – condition without findings.
- Covers AC classification 1 – condition without findings.
- General condition, weathering AC classification 1 – condition without findings.

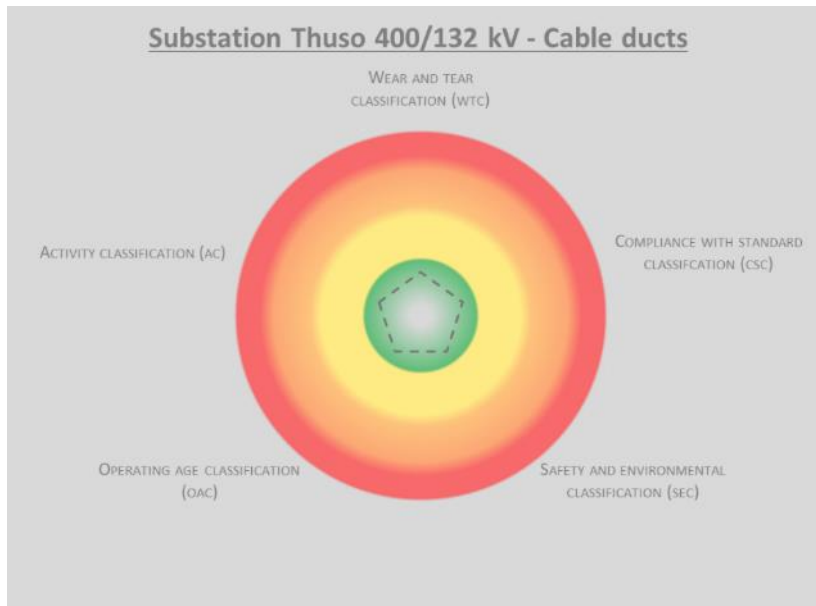
Figure 9-89: Evaluation graphic of cable ducts in substation Thuso

The cable ducts correspond to the condition that it was commissioned less than ten years ago and is according to the current state of technology. Cleanliness and maintenance condition are excellent (see Figure 9-89).

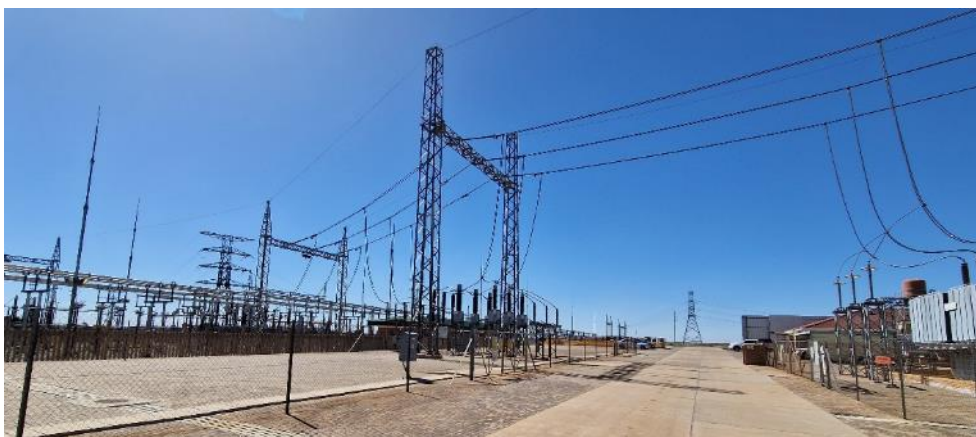
Figure 9-90: Substation Thuso

The Thuso substation was commissioned in 2014. No noticeable wear and tear have been observed on any of the plant components as a result of operation to date (see Figure 9-90). This corresponds to the relatively short period of operation of the substation, but also results from the good maintenance and servicing by the substation staff. Accordingly, no activities are necessary to improve the condition and all assessment classes were classified as 1 (see Figure 9-91, AC 1).
